MOUNT VERNON FIRE STATION STRUCTURAL ASSESSMENT STUDY Mount Vernon, Iowa

**MOUNT VERNON FIRE STATION
STRUCTURAL ASSESSMENT STUDY
FINAL
Mount Vernon, Iowa**

March 12, 2009

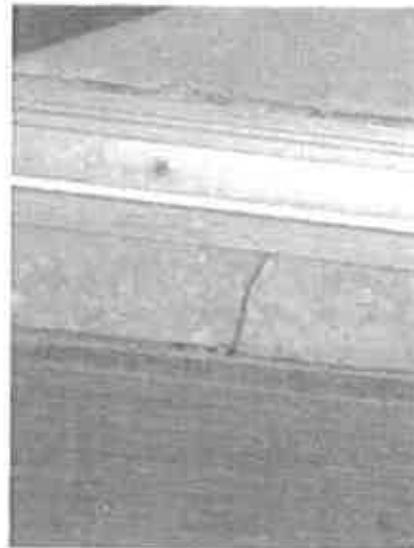
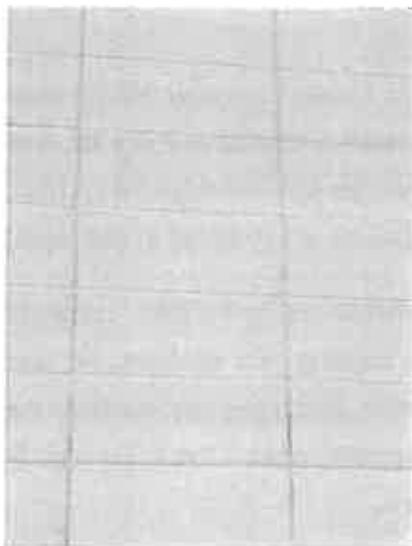
1. The slab-on-grade in the north end of the Apparatus Room had settled approximately $\frac{1}{2}$ " to $\frac{3}{4}$ " relative to the perimeter foundation wall.
2. The perimeter foundation wall is cracked at the southeast pedestrian door.

The structure condition for the Apparatus Room is fair to good. It is HR Green's opinion that the Apparatus Room's issues noted above could be rehabilitated and the area renovated in conjunction with an addition to the Fire Station.

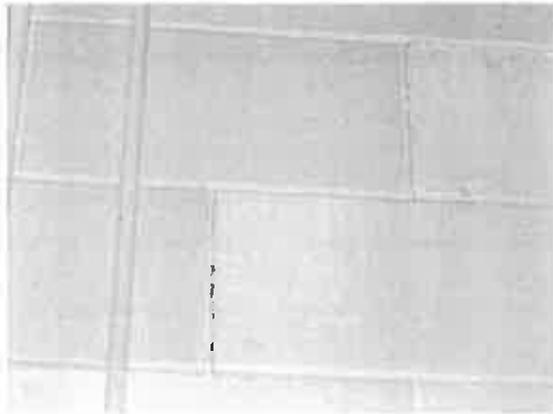
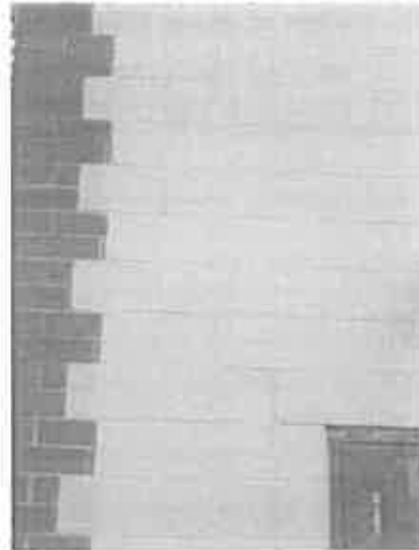
3. CMU pilasters are cracked vertically on the outside face. It appears that the joints are control joints and are intended to be a weak point for cracking to occur.

4. CMU joints in the southeast corner have stair stepped cracks in the interior and exterior face of the wall.

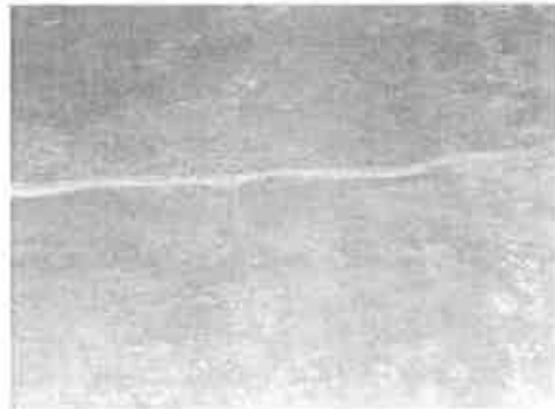
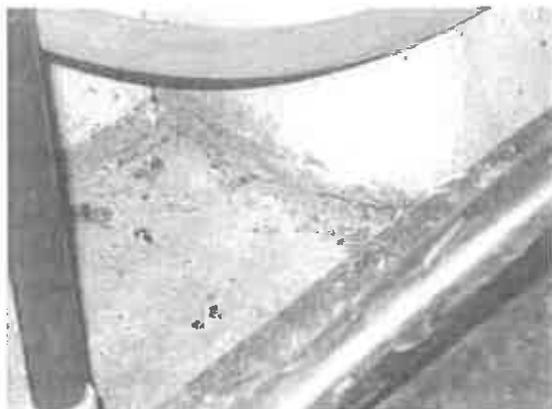
5. The slab-on-grade is cracked in several locations. Vertical displacement across the crack was noted in the south end of the Apparatus Room.

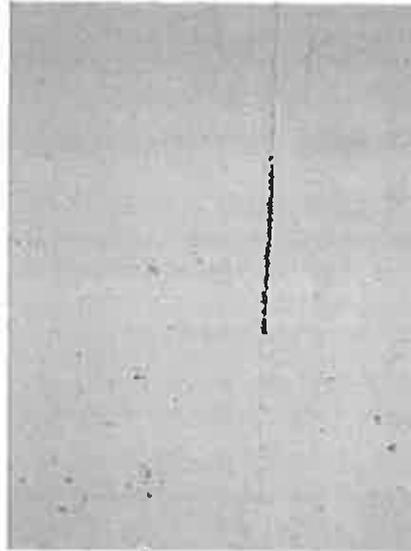
6. A gap was noted between the bottom of the CMU for the most northerly pilaster on the west wall and the concrete surface.

7. Vertical cracks spaced at approximately 6 feet on center were observed in the exposed exterior east perimeter foundation wall.

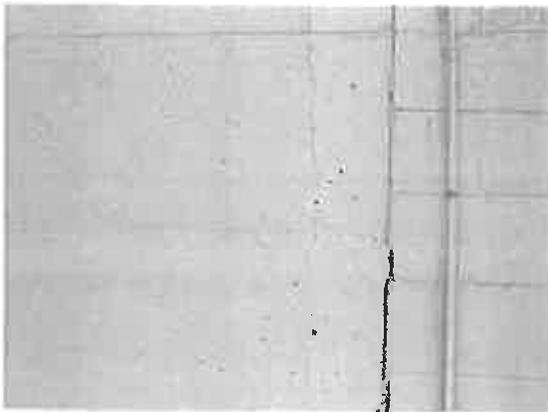
8. The sealant between the paving and perimeter foundation wall has deteriorated.

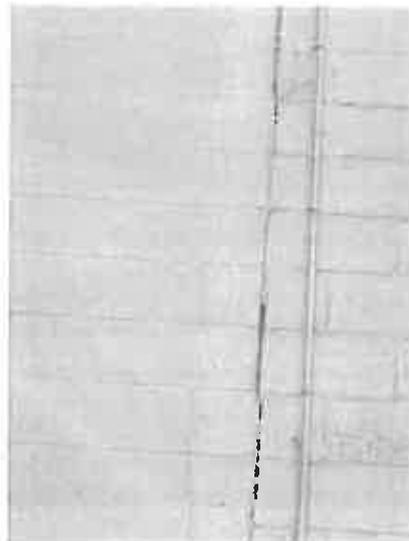
9. A vertical crack in the exterior face of the east perimeter wall was noted approximately 20' from the north end of the building. The crack width varied from 20 mils to 60 mils wide.

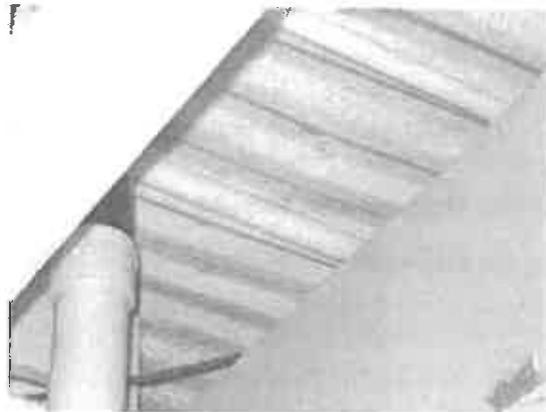
1. Cracks were observed in the CMU north exterior walls below the windows.

2. An area of damaged floor deck was noticed above the laundry area.

Areas of the steel floor deck at the north end of the building have corroded and would need to be replaced if the structure was rehabilitated as part of the building addition.

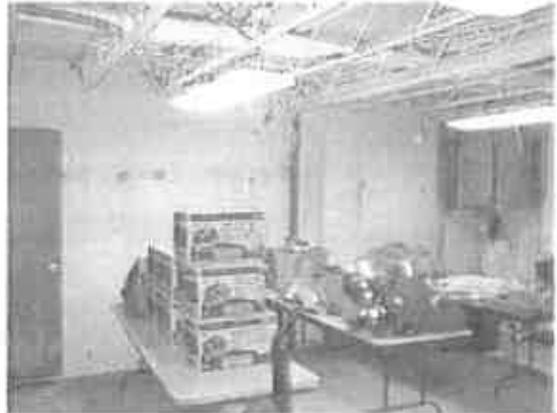
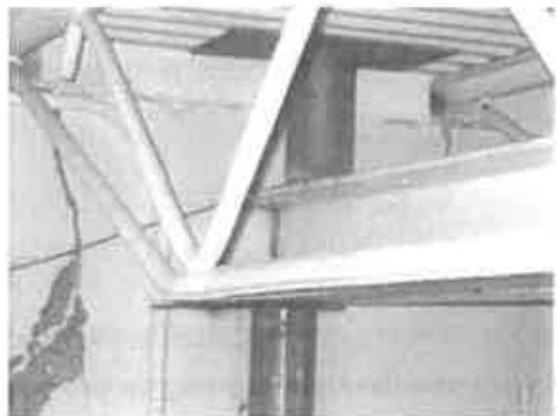
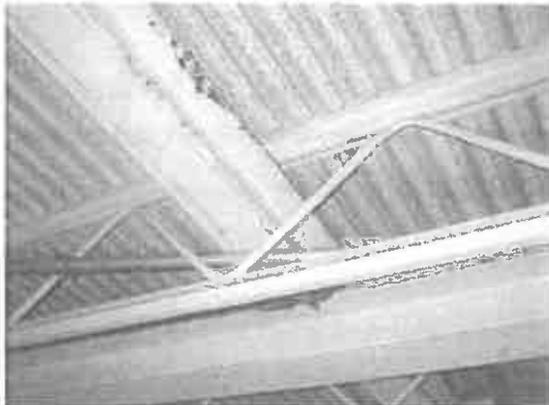
5. The main level floor framing above the Meeting Room has been shored. 5" wide flange members span approximately 18' in the east-west direction and provide support for the bar joists' top chord member. One beam was located approximately 5'-9" north of the south wall and the second beam approximately 6'-0" north of the first beam. The two beams are supported at the bottom flange by another 5" wide flange spanning from the south wall to the north wall. This is a span of approximately 20'-1". Each wide flange is supported by pipe columns at their ends.

The structure condition for the north end of the structure is fair to poor. The shoring installed below the main level in the meeting Room is inadequate to support the minimum design live loads per the International Building Code. In addition, the depth to span ratio for the members is less than what is considered good engineering practice. This could result in serviceability problems related to excess deflection when the members are subjected to maximum loads.

Bar joist top and bottom chord members are typically designed for axial loads (tension or compression) only. With the wide flange member supporting the top chord member between panel joints, the top chord is subjected to bending stresses. The bar joist was probably not designed for this loading condition.

It is HR Green's opinion that the North End of the existing Fire Station should not be renovated as part of an addition to the building. The replacement recommended for the floor and roof structure makes it more feasible to demolish this end of the building and add a new structure with the addition to accomplish the space programming that may be utilized for this area.

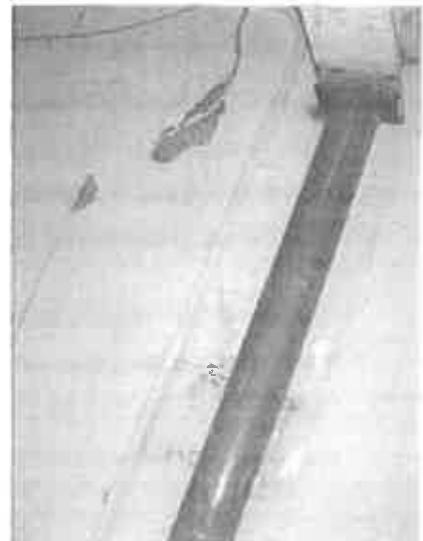
6. A diagonal crack in the south cast-in-place concrete wall in the Meeting Room was observed. The crack is in the vicinity of the shoring member. The crack was measured to be approximately 20 mils to 30 mils wide.
