Re: Geophysical Exploration Report  
Mt. Vernon Pool – GPR Services  
919 2<sup>nd</sup> Avenue North  
Mt. Vernon, Iowa  
Terracon Project No. 06153521

GROUND PENETRATING RADAR
Mt. Vernon Public Pool 919 2 <sup>nd</sup> Ave N. MT VERNON, IOWA

MOUNT VERNON POOL STRUCTURAL INVESTIGATION  
LETTER REPORT

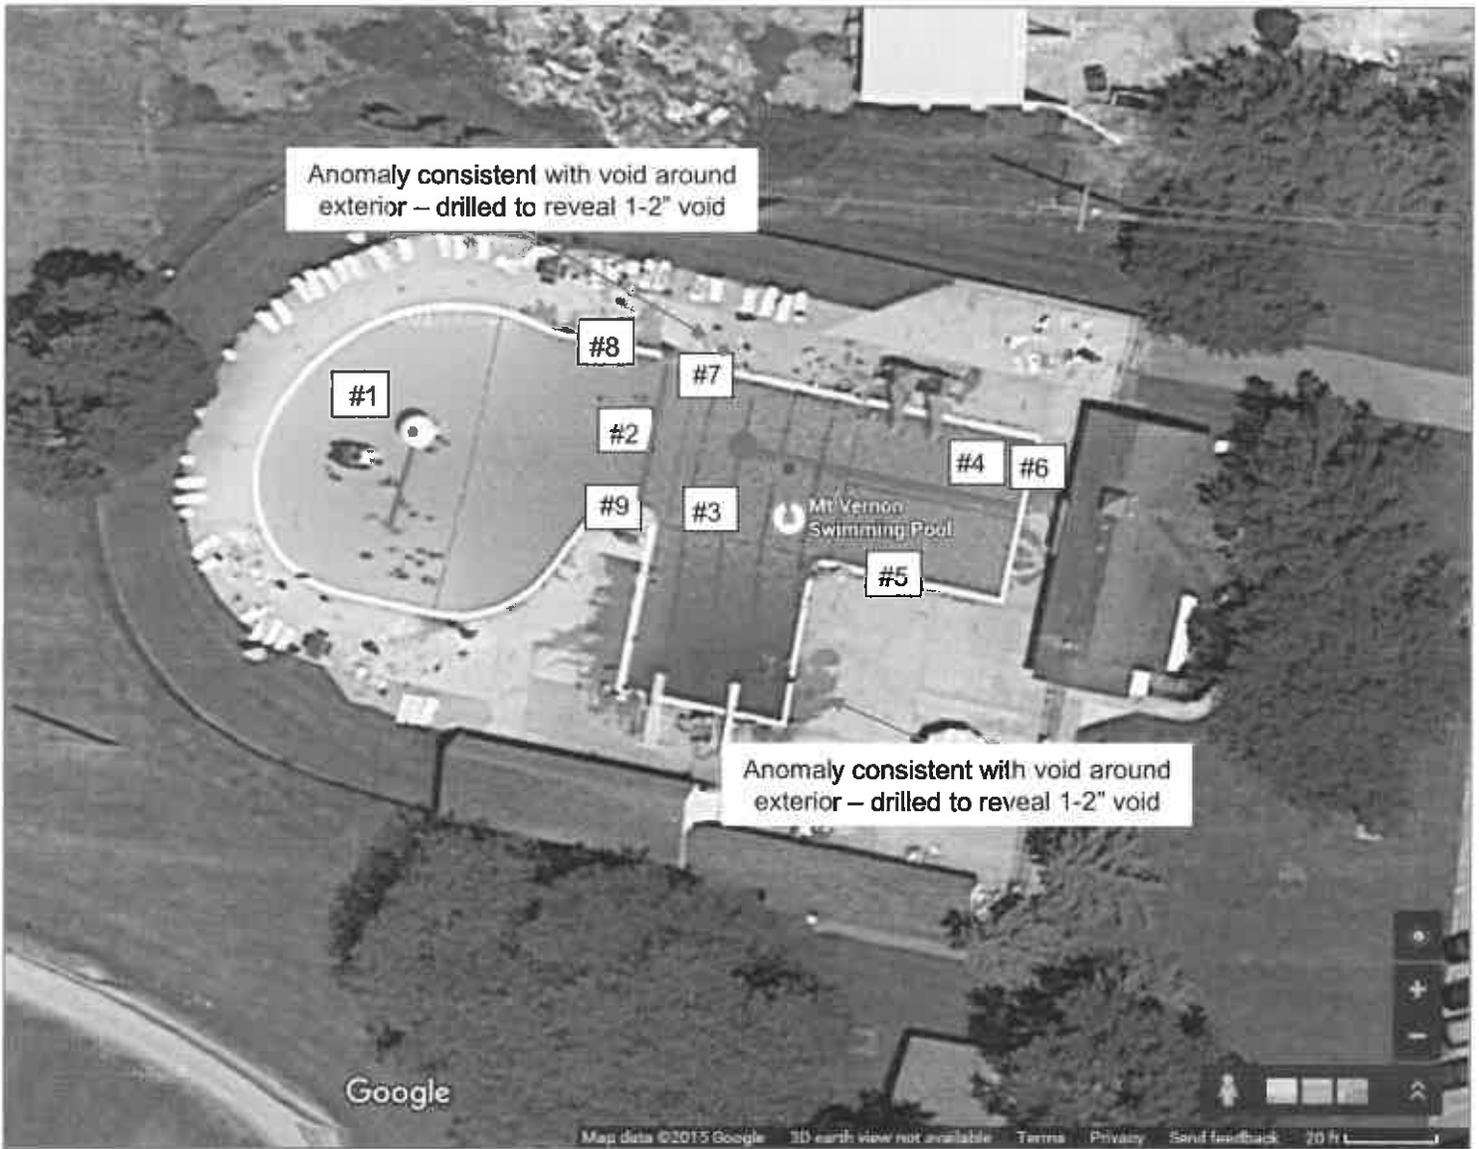
EXHIBIT
1

The various anomalies that were encountered during the scan as well as the locations of the 9 areas scanned for structural information are shown in the attached Exhibit 1. The structural information is provided in the tables below.

Locations of anomalies observed in the field are presented in the attached Exhibit. Two probable drains were encountered in the older portion of the pool. A utility was also detected that appeared to feed into the mushroom-shaped piece in the new portion of the pool. Anomalies consistent with voids were encountered around most of the pool deck out to 2-3 feet away from the pool. Small holes were drilled in two locations and small 1-2 inch voids were encountered. The holes were patched with an epoxy before leaving the site.

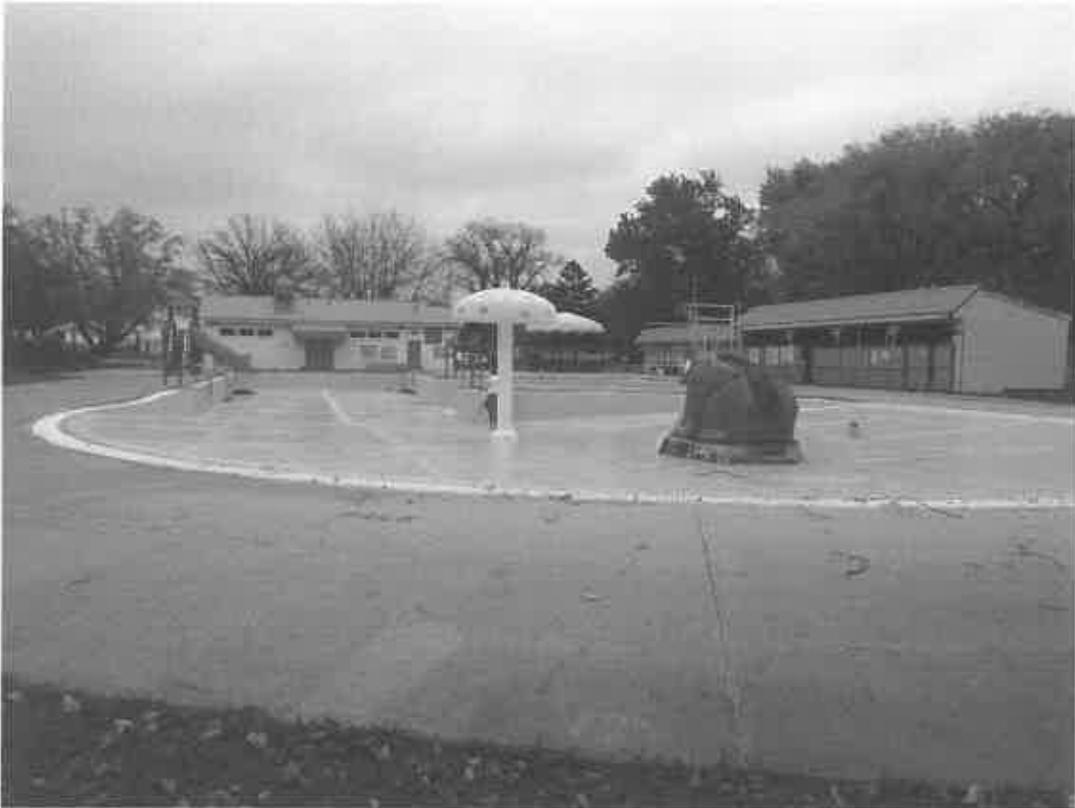
As reported by Mr. Nick Nissen on the date of our site visit, the original pool was constructed in the 1960s with an addition being constructed at the west end of the pool at a later date. Photo 1 is a view the pool from the west. As part of our investigation, the floor and walls of the pool were observed to identify visible cracks where leaking could occur. Photo 2 shows typical cracks that were observed in the floor of the pool. Approximately 265 lineal feet of crack were identified in the floor of the original pool. No cracks were observed in the floor of the more recently constructed addition.

Photo 1 Looking East at Swimming Pool

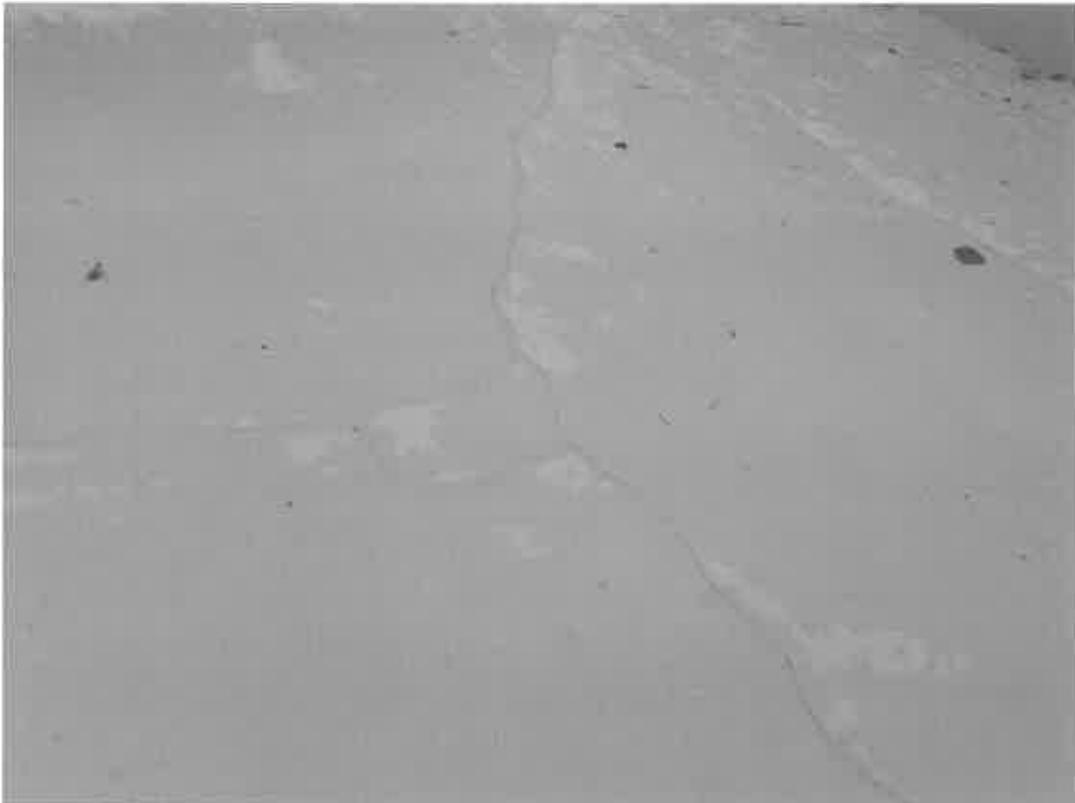
Photo 2 Typical Cracks in Floor

Mr. Nissen indicated that the cracks in the floor of the pool are repaired at an approximate 5 year interval. The method used for the past repairs should be investigated to determine if a surface caulk or pressure installed epoxy injection was used to repair the cracks. Pressure installed epoxy would be more effective than a surface applied caulk. Depending on the method used for repair, further investigation may be needed to approximate the amount of leakage through the cracks.

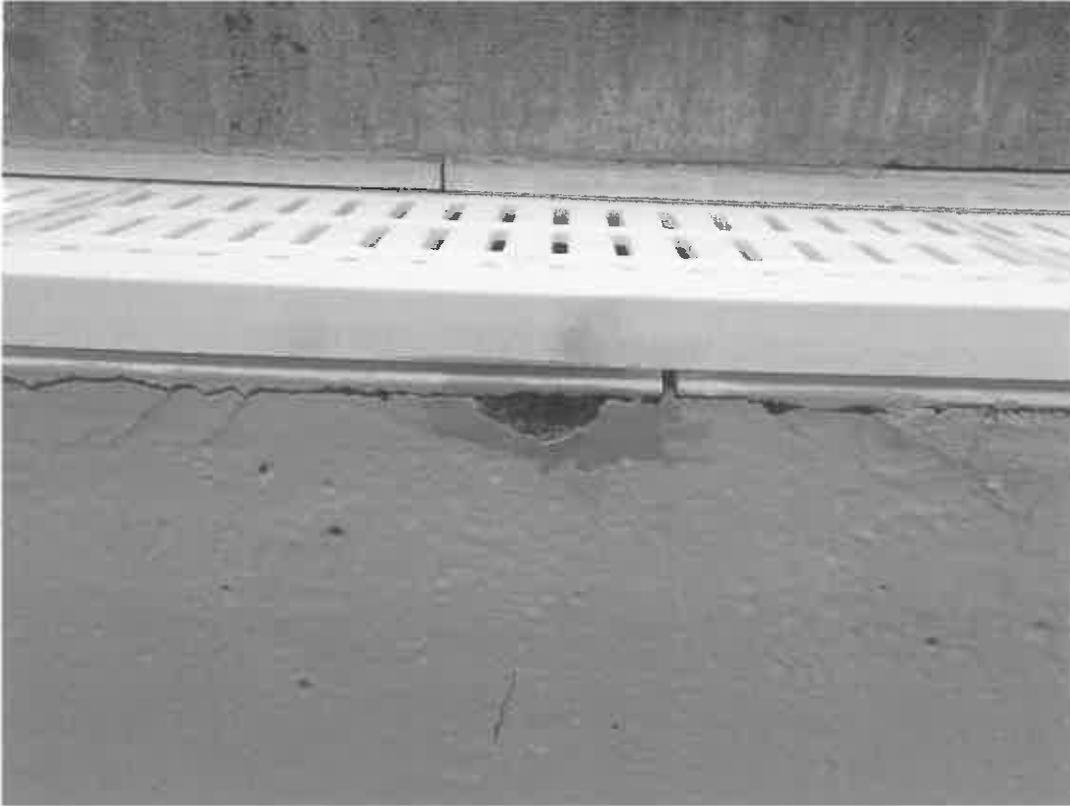
The walls of the pool had relatively few cracks, but the masonry grout at the top of the trough wall was deteriorated where the plastic cover was added. The deteriorated grout is shown in Photo 3. It should be noted that the deteriorated grout would not allow leakage from the pool. At one location along the north wall the plastic cover was

Photo 3 Deteriorated Grout at Trough Below Plastic Cover

Remove the remainder of the plastic cap at the trough to see if unrepaired cracks exist in the trough.

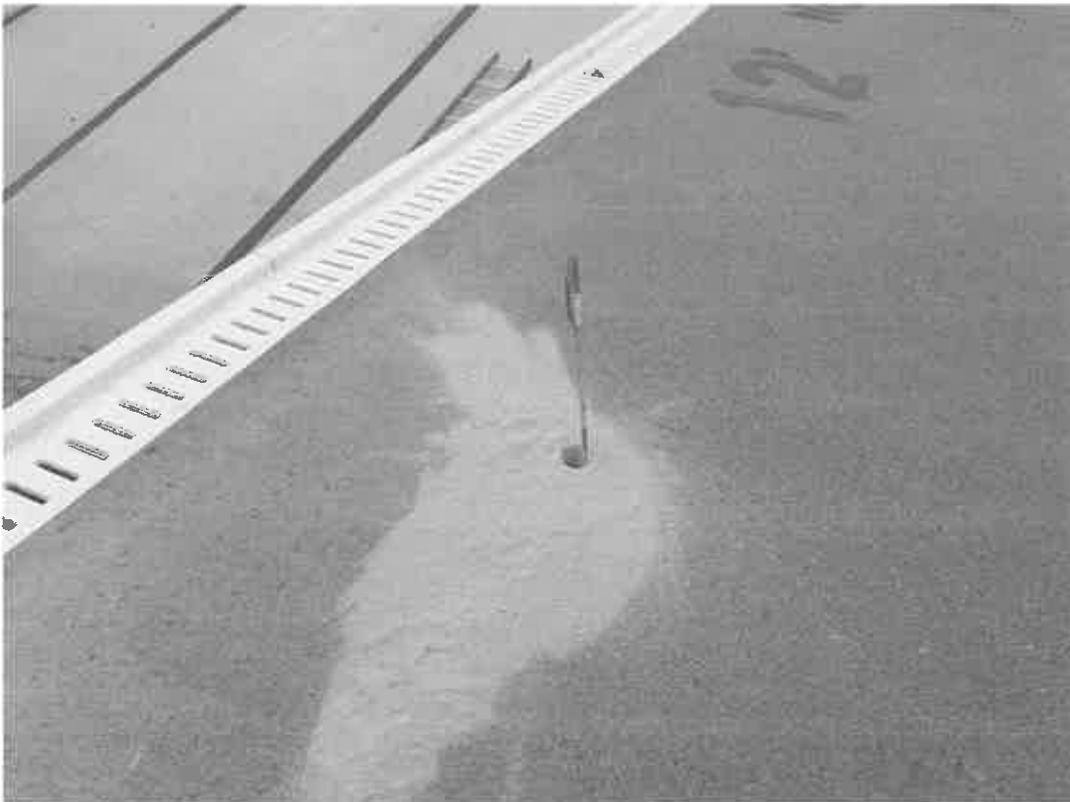
In addition to our visual observation, the floor and walls were sounded with a chain and/or hammer to identify hollow sounding areas. Hollow sounds can indicate either a void below or behind the floor/wall or delamination of the concrete. Voids can occur where the underlying soil has settled and this can occur at leaking areas where water can erode the soil. Delamination occurs where expansive force created by corroded steel reinforcement in the concrete causes the exterior surface of the concrete above the reinforcement to break free. The results of the sounding indicated approximately 40 square feet of hollow area exists below the floor and approximately 2 square feet behind the wall. Ground penetration radar (GPR) was used by Terracon to verify the approximate location, size, and depth of the voids/delaminations. Probe holes were also drilled in the deck slab at two locations behind the walls (See Photo 4 for typical probe hole). The results from the sounding, GPR and probe holes did not identify void locations that we could conclude to be the results of leakage.

Photo 4 Probe Hole in Deck Behind Wall
