Re: Geophysical Exploration Report
Mt. Vernon Pool – GPR Services
919 2nd Avenue North
Mt. Vernon, Iowa
Terracon Project No. 06153521.02

Re: Geophysical Exploration Report
Mt. Vernon Pool – GPR Services
919 2nd Avenue North
Mt. Vernon, Iowa
Terracon Project No. 06153521

MOUNT VERNON POOL STRUCTURAL INVESTIGATION LETTER REPORT

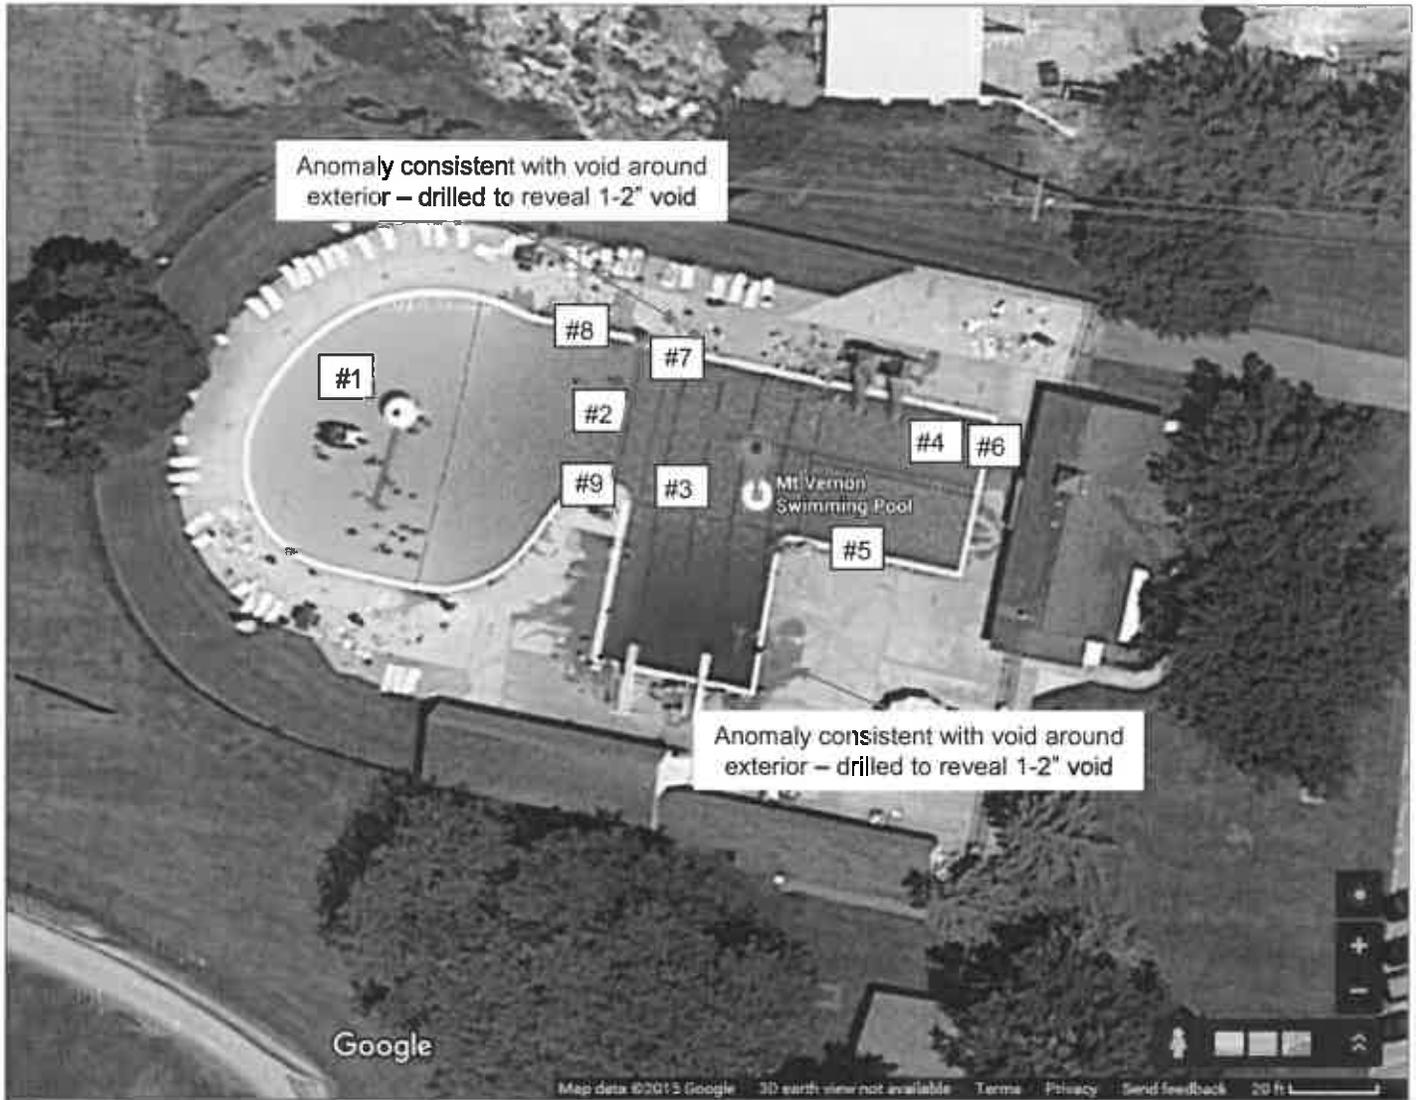
EXHIBIT
1

The various anomalies that were encountered during the scan as well as the locations of the 9 areas scanned for structural information are shown in the attached Exhibit 1. The structural information is provided in the tables below.

Locations of anomalies observed in the field are presented in the attached Exhibit. Two probable drains were encountered in the older portion of the pool. A utility was also detected that appeared to feed into the mushroom-shaped piece in the new portion of the pool. Anomalies consistent with voids were encountered around most of the pool deck out to 2-3 feet away from the pool. Small holes were drilled in two locations and small 1-2 inch voids were encountered. The holes were patched with an epoxy before leaving the site.

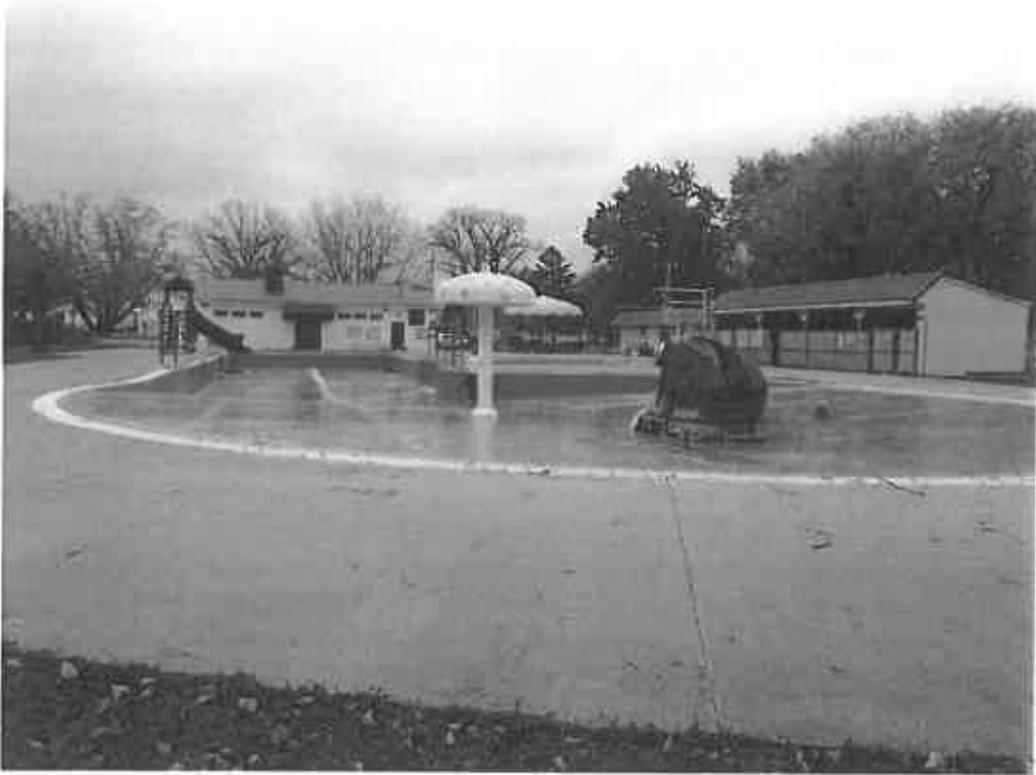
Photo 1 Looking East at Swimming Pool

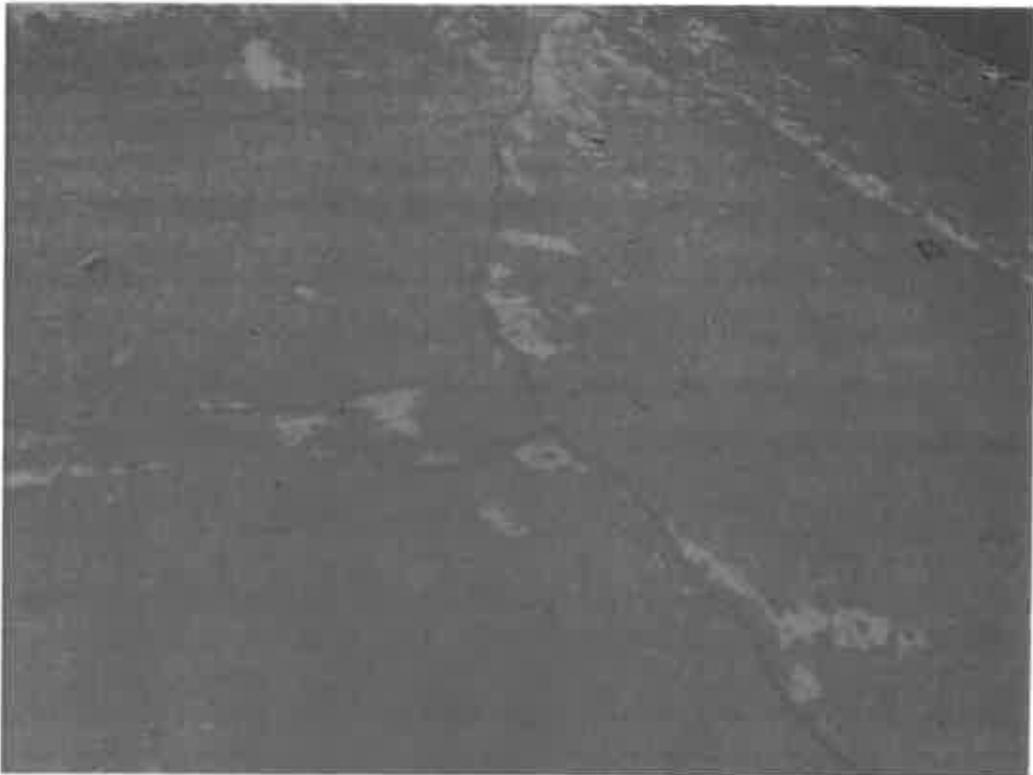
As reported by Mr. Nick Nissen on the date of our site visit, the original pool was constructed in the 1960s with an addition being constructed at the west end of the pool at a later date. Photo 1 is a view the pool from the west. As part of our investigation, the floor and walls of the pool were observed to identify visible cracks where leaking could occur. Photo 2 shows typical cracks that were observed in the floor of the pool. Approximately 265 lineal feet of crack were identified in the floor of the original pool. No cracks were observed in the floor of the more recently constructed addition.

Photo 2 Typical Cracks in Floor

Mr. Nissen indicated that the cracks in the floor of the pool are repaired at an approximate 5 year interval. The method used for the past repairs should be investigated to determine if a surface caulk or pressure installed epoxy injection was used to repair the cracks. Pressure installed epoxy would be more effective than a surface applied caulk. Depending on the method used for repair, further investigation may be needed to approximate the amount of leakage through the cracks.

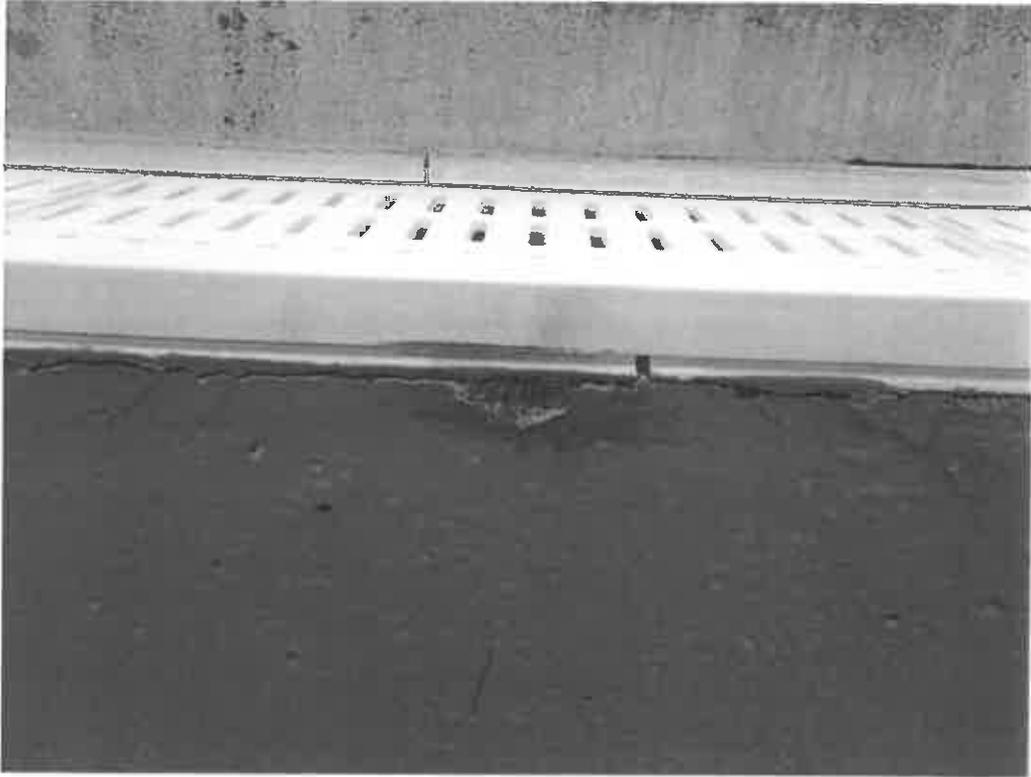
The walls of the pool had relatively few cracks, but the masonry grout at the top of the trough wall was deteriorated where the plastic cover was added. The deteriorated grout is shown in Photo 3. It should be noted that the deteriorated grout would not allow leakage from the pool. At one location along the north wall the plastic cover was removed to allow observation of a crack in the trough wall that had been repaired. The plastic cover was not removed at any other locations so the majority of the trough was not observed.

Photo 3 Deteriorated Grout at Trough Below Plastic Cover

Remove the remainder of the plastic cap at the trough to see if unrepaired cracks exist in the trough.

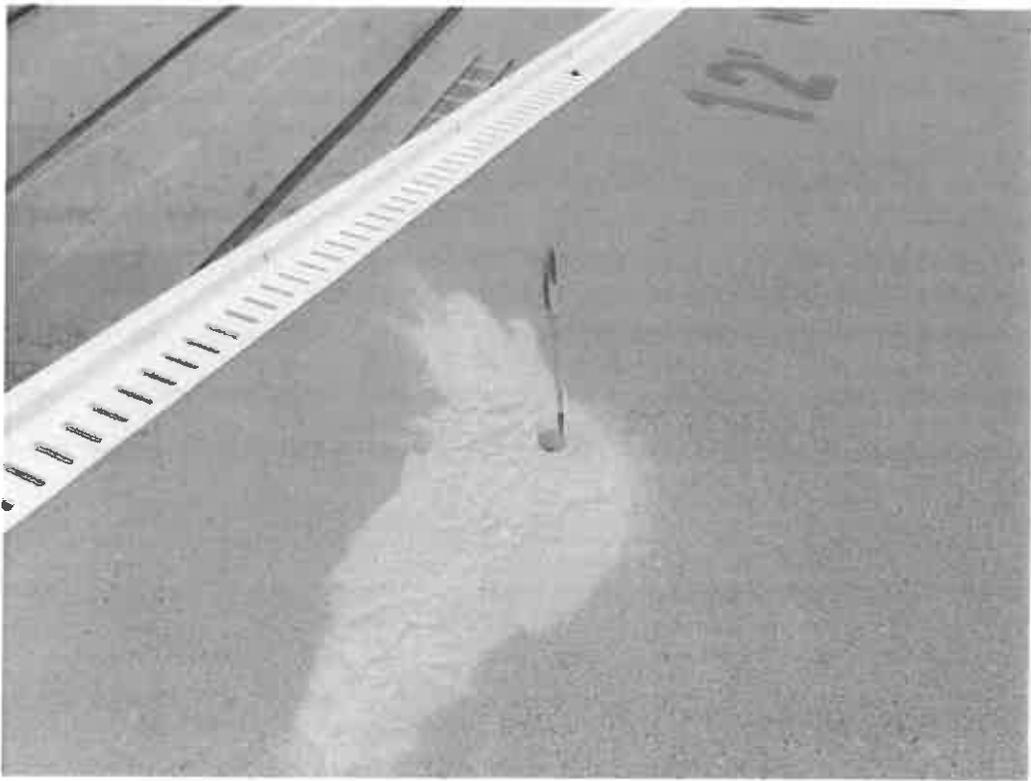
Photo 4 Probe Hole in Deck Behind Wall
