### Highway 1 Crossings | 4th Street

# Mount Vernon

## Highway 1 Crossings | 4th Street (sheet 2 of 2)

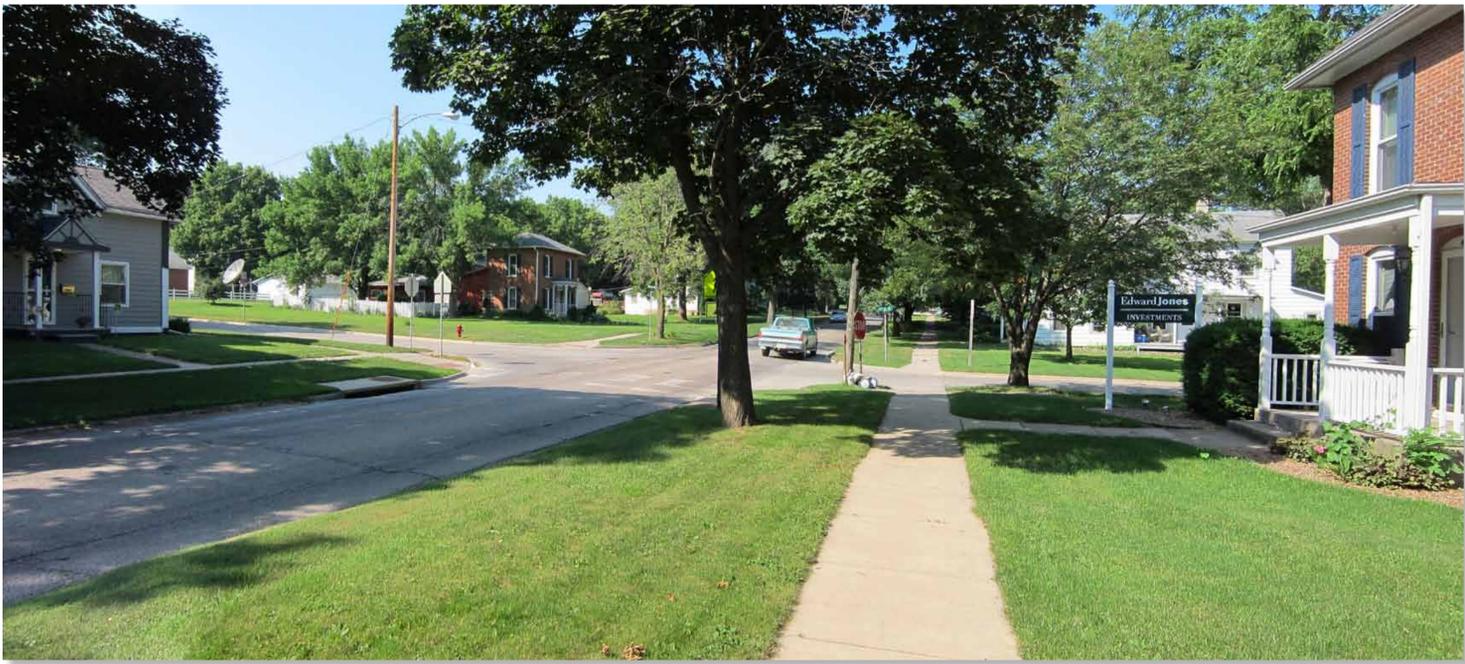
Looking north along Highway 1 near 4th Street at the existing site conditions.

Highway 1 carries a lot of traffic from Highway 151 to the north to Interstate 80 to the south. The current corridor contains sidewalk along both sides of the street for much of its distance through town. The sidewalk condition is in average to poor condition. This arterial street acts as a barrier for pedestrian traffic and presents safety concerns at particular intersections. Speeding traffic is also a concern when inviting pedestrians into this area. Certain cross streets maintain less than adequate sight distance at intersections for crossing pedestrian traffic. This is due to topography issues and is most evident at intersections with Palisades Road, 2nd Street South, 2nd Street North and Webster Street to name a few.

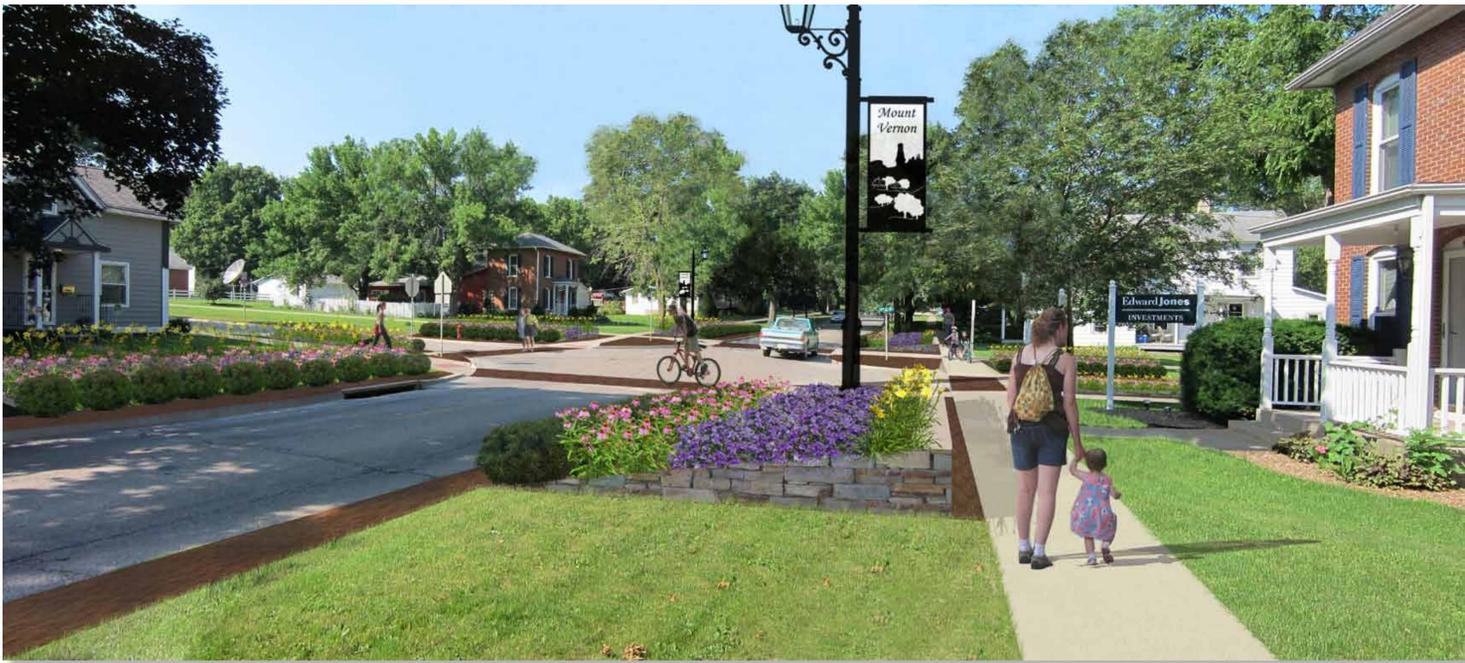
Proposed enhancements at the intersection of Highway 1 and 4th Street to improve pedestrian safety.

The preferred crossing locations are slated to receive streetscape enhancements that suggest to motorists that they have entered a pedestrian zone. The enhancements include accent plantings within raised planters, decorative street lights, accent colored paving materials for splash zones along curb and highlighted crosswalks. The additional street lights are essential at these designated crossing locations to improve the visibility of pedestrians. Current lighting levels are generally not adequate to invite pedestrian traffic. These select streetscape enhancement features serve as traffic calming elements and will draw attention of motorists, making Highway 1 crossing safer and more pedestrian friendly.

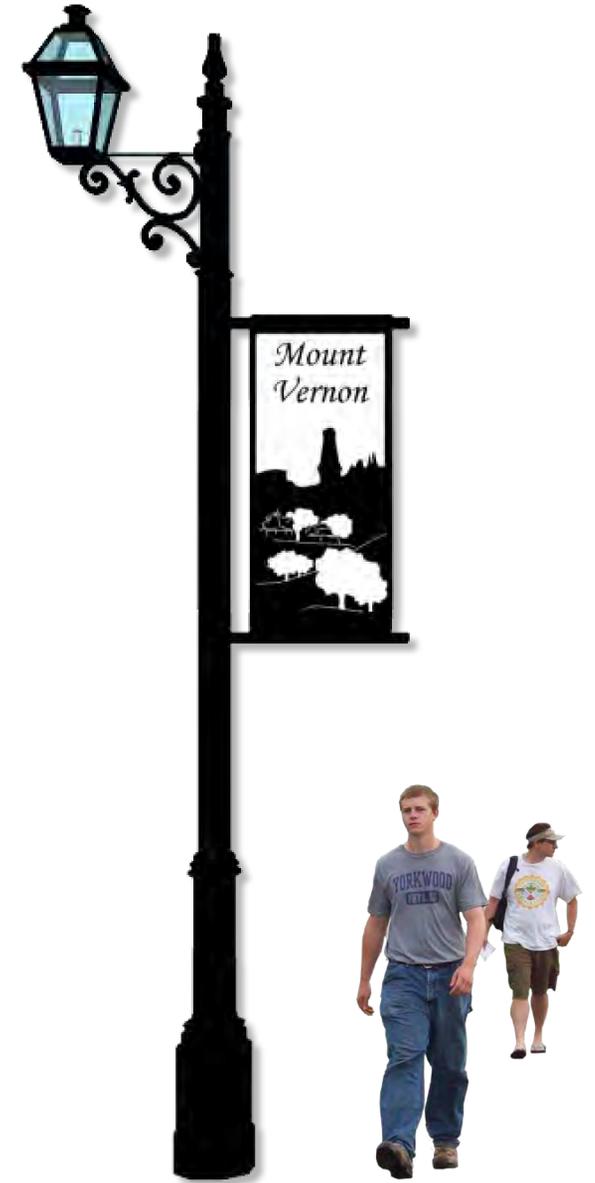
Street lighting with community banner.
